**Docket No. 217 – Development and Management Plan Inspection**

Northeast Utilities Service Company Certificate of Environmental Compatibility and Public Need for the construction of a 345-kV electric transmission line and reconstruction of an existing 115-kV electric transmission line between Connecticut Light and Power Company's Plumtree Substation in Bethel, through the towns of Redding, Weston, and Wilton, and to the Norwalk Substation in Norwalk, Connecticut.

**Date:** March 15, 2005

**Location:** 345kV XLPE Component

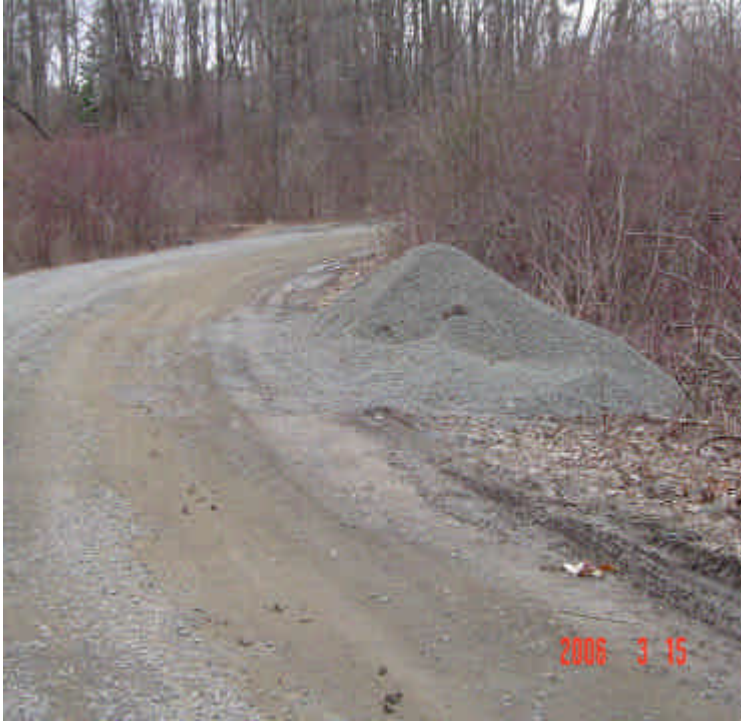
- Trenching along the access drive to Plumtree Substation is largely complete. 3/15/06  -Several stone piles remain along the drive adjacent to wetland swales. 3/2-3/15/06  - Use of the dewatering box is complete and a good amount of soil was filtered. This will be	- Work was performed very well with minimal encroachment on swales and no sedimentation 3/15/06  - Now that work is complete, remove remaining stone from swales. 3/2-3/15/06  -The small disturbed area within the swale should be regraded and restored. 3/15/06	-N/A
Erosion and Sediment Controls (includes inspection within 24 hours of a storm event)			
Plumtree Substation Drive

**345kV XLPE (Plumtree Substation):** Photo on the left shows the largest stone piles left behind along the Plumtree access drive. This should be removed as it encroaches on the swale. Photo on the right shows the completed trench work in the drive near Walnut Hill Rd. 3/15/06

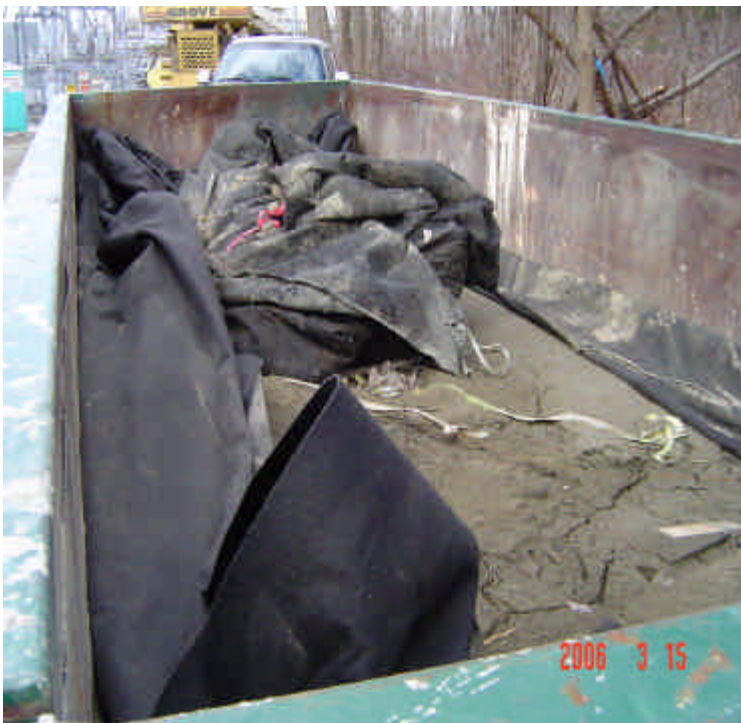
Photo on the left shows the dewatering box which is being removed from site due to completed work here. A significant amount of sediment was filtered from the trench. Photo on the right shows where the box had been within the wet swale. The area could use a little restoration. 3/15/06

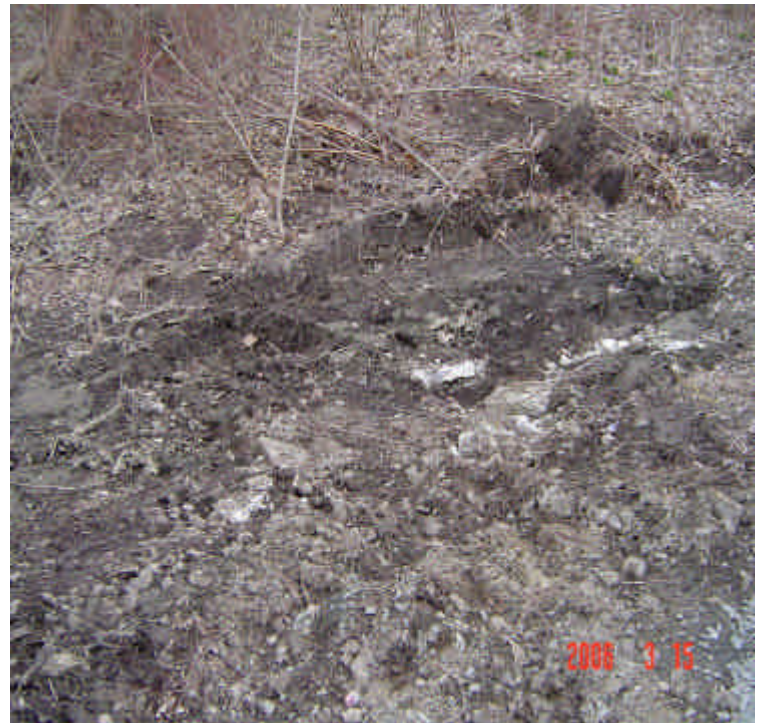
Areas of Inspection	Observation	Recommended Action	Corrective Action
<b>Jack and Bore</b>	disposed of properly. Removal of the box caused some minor disturbance to the wetland swale. 3/15/06

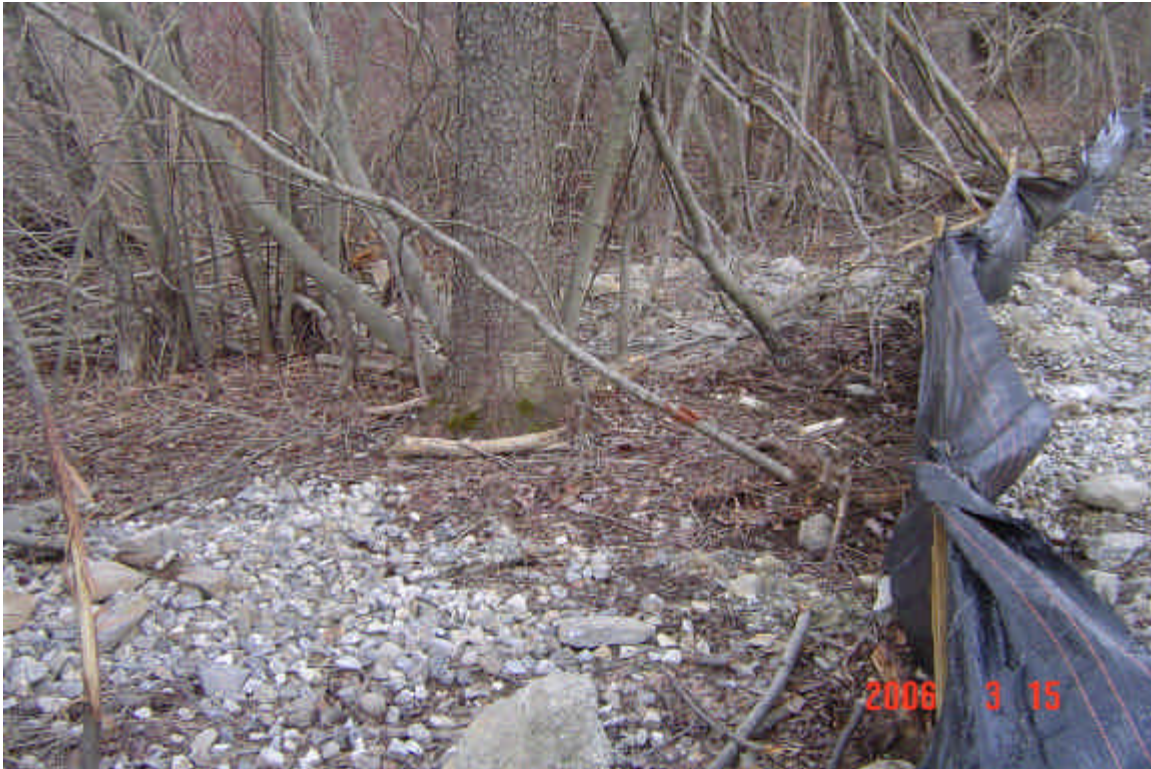
- Silt fence at vault 2A&B was well in place but several piles of stone had been placed over it as a result of plowing. 3/2-3/16/06	- Stone piles should be placed back on the work side of the fence as soon as feasible. One of the piles can remain as work is coming through that area. 3/15/06	
	-Silt fence was placed at the stockpile along the perimeter fence at the J&B pad as recommended. 3/16/06	-Good controls are in place. 3/15/06	-Silt fence was installed as recommended. 3/15/06
<b>Whittlesey Drive</b>	-A plastic liner remains installed in the stream bed and up the banks. Stone was installed over it within the stream and soil was placed to secure it on the banks. 2/16-3/15/06	-Silt fence was still in place above the liner but continue to monitor the disturbed area below for sedimentation. The stream was running clear at the time. 3/15/06	- N/A at this time

(Vault 2A&B): Photo shows some stone piles beyond the silt fence as a result of snow plowing. Stone should be carefully removed from the wetland side of the fence. 3/15/06

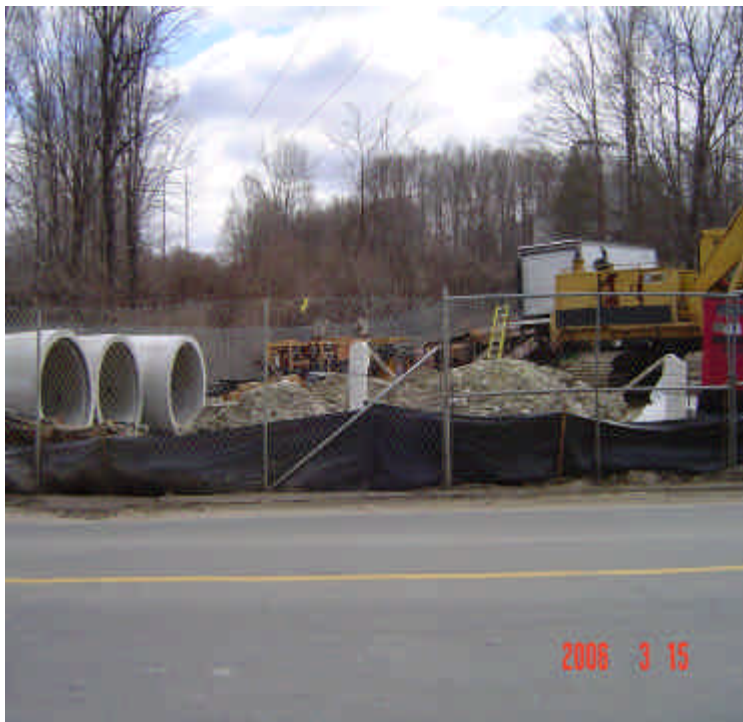
(Jack and Bore): Photo on the left shows a view of the bore pad. Additional erosion controls were installed to encompass the new sediment pile. Photo on the right shows the dewatering box working at this location. 3/16/06

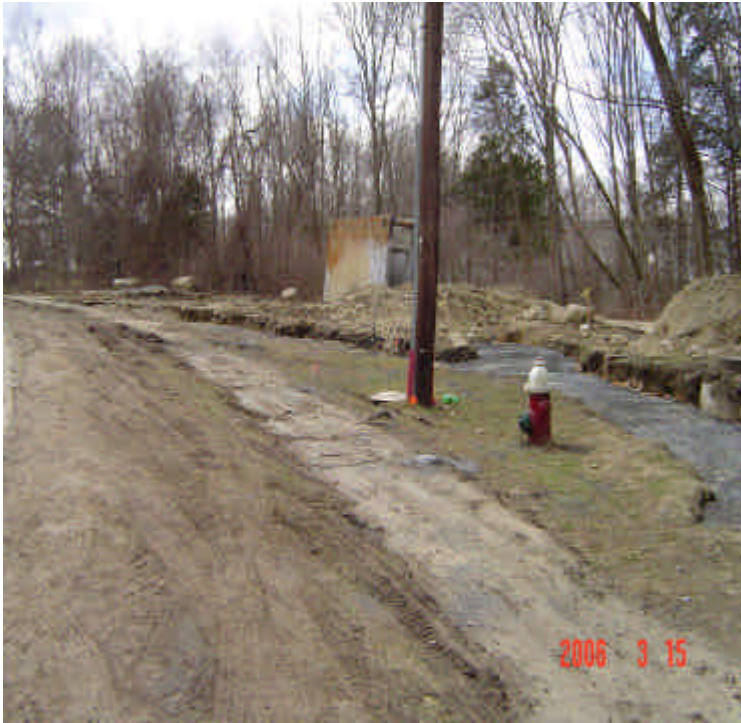
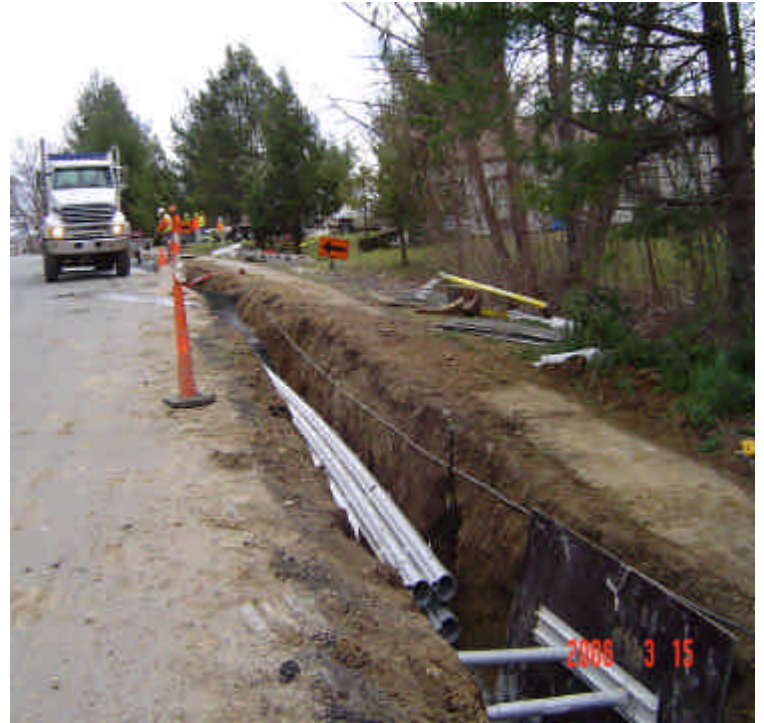
(Whittlesey Drive): Both photos show views of the active trenching in various stages of construction along Whittlesey Drive. 3/15/06

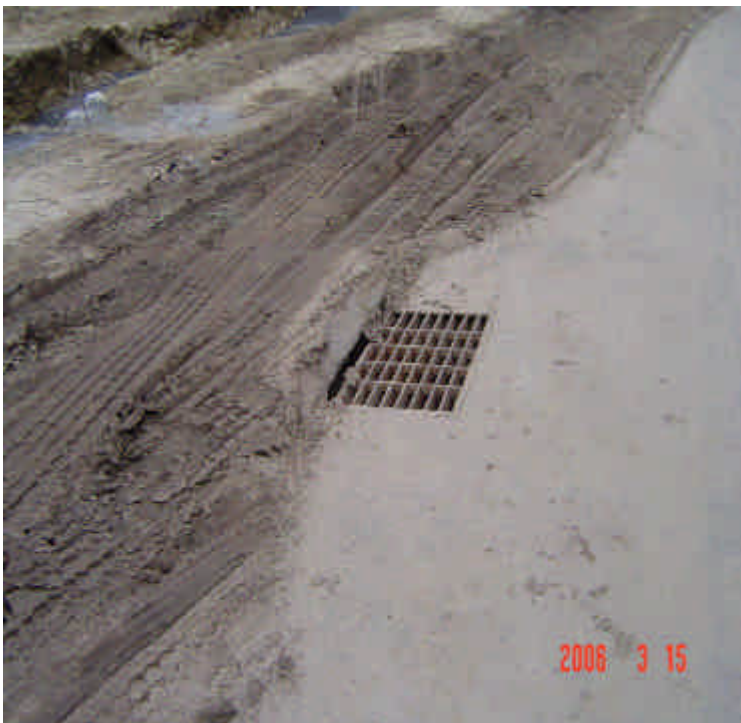
- A few catch basins along Whittlesey Dr. required controls due to adjacent sediment. 3/15/06	- These areas were shown to the contractor and haybales or silt bags will be placed. 3/15/06	
	-Work within the access drive to Plumtree Substation is largely complete. A few stone piles remain to be removed. 3/15/06	- See erosion control section for recommendations.	- N/A
	-The stone access off Rt. 58 has been extended using portable mats as	-The mats provide a stable working surface and protect the wetlands well.	- Mats were installed to extend access through the

Photo on the left shows a catch basin along Whittlesey Drive which will be placed with controls. Photo on the right shows completed trenching within the student parking lot off Whittlesey Dr. 3/15/06

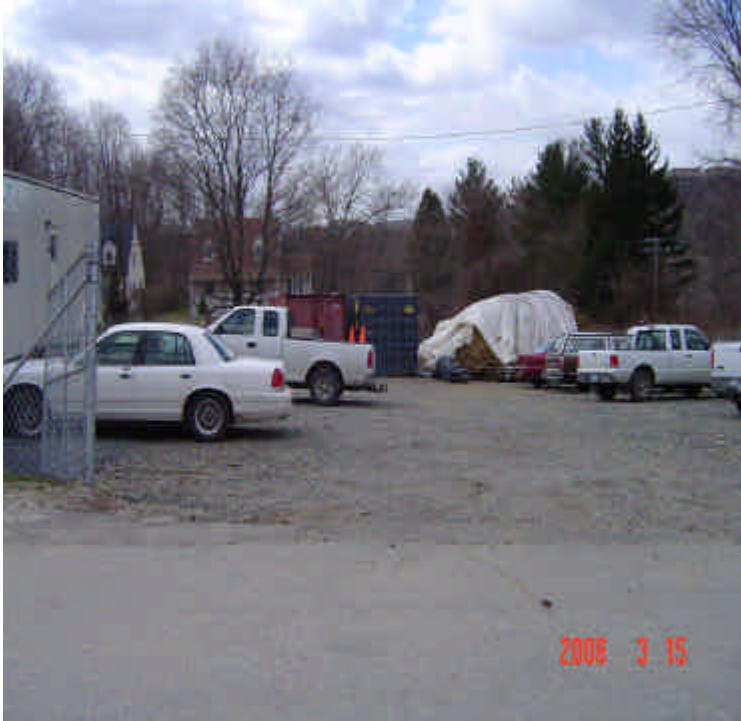
- A topsoil stockpile is in place at an office/storage area for the contractor. The stockpile is covered in plastic and silt fence is installed at the base. 3/15/06	- Controls are well in place at this time. 3/15/06	- N/A
<b>Hoyts Hill</b>	-Mats are well in place and trenching was occurring near the retaining wall. Dewatering was necessary but good controls, including a filter bag, were being used. 3/15/06	- Water from the bag was clear at the time of inspection, but some adjacent areas had turbid water. This may have been from transition station dewatering. The contractor agreed to fix a hole in the adjacent silt fence even though their	-N/A

Photo on the left shows the storage and office area for the contractor while working on site. A topsoil stockpile is covered in plastic with silt fence at the base. Photo on the right shows the access installed off Rt. 58 at Hoyts Hill. Portable mats were also installed for stabilization. 3/15/06

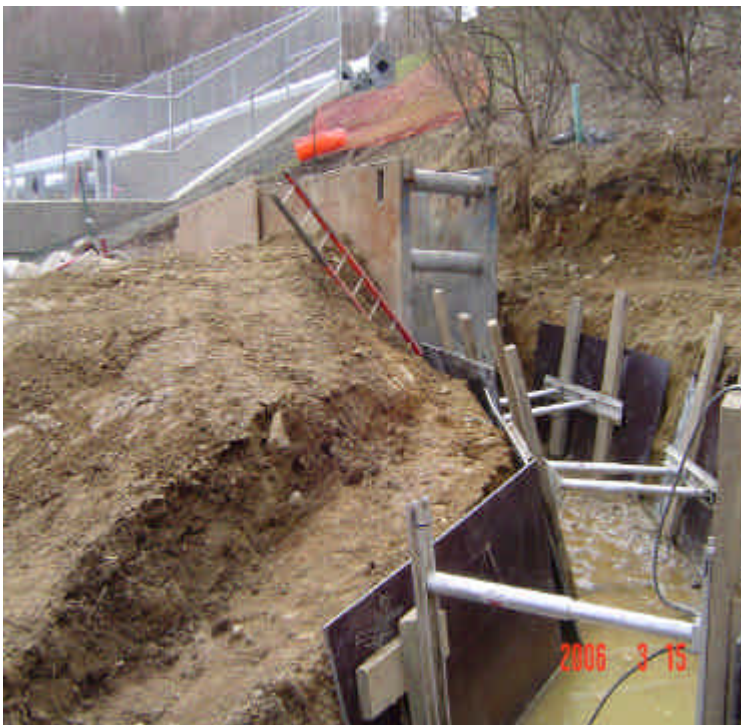
Photo on the left shows the initial trenching out of Hoyts Hill. Photo on the right shows active dewatering from the trench to a filter bag and erosion controls. The water filtering from the bag was clear at the time of inspection. 3/15/06
